Gunite Brake Drums

Maintenance and Installation Manual

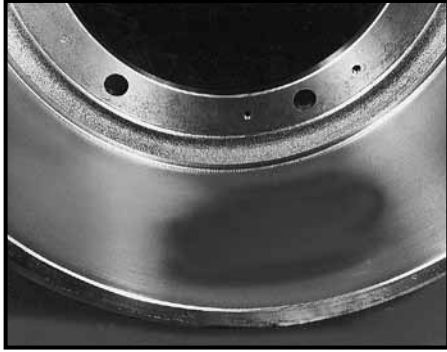
Grease-Stained Drums

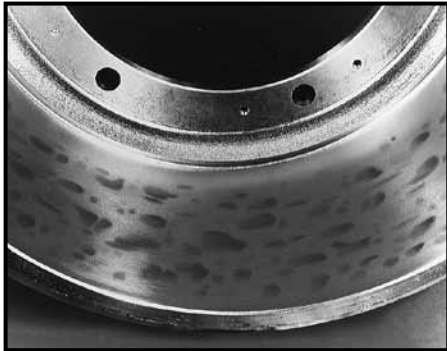
Martensite Spotted Drums

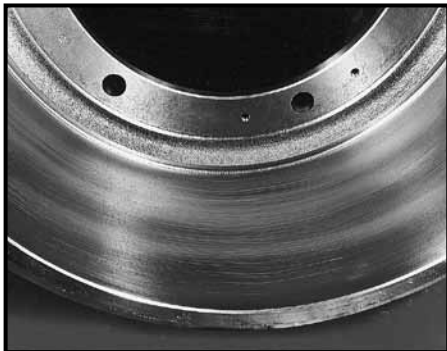
After replacing the brake drum, the entire braking system should be checked for proper balance between the tractor and the trailer as well as wheel to wheel (i.e., air distribution, brake adjustment, and power A/L factors).

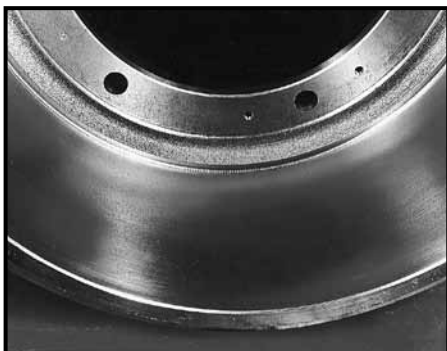
When checking brake drum diameter for wear, the diameter should not exceed 0.120" over the original diameter. When reboring brake drums, the finished diameter should not exceed 0.080" over the original diameter.

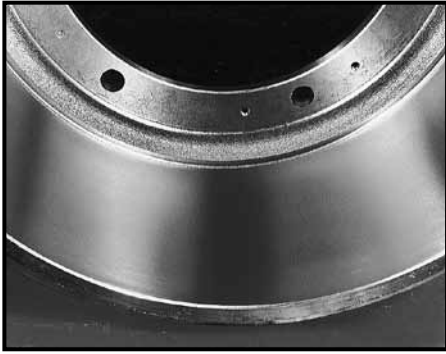
If this condition is left unresolved, it can result in the development of a martensite condition or cause the drum to crack.

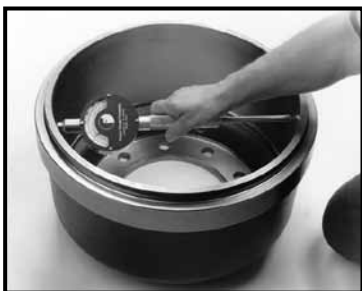
When checking brake drum diameter for wear, the diameter should not exceed 0.120" over the original diameter. When reboring brake drums, the finished diameter should not exceed 0.080" over the original diameter.

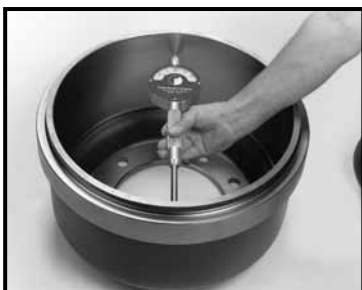
When checking brake drum diameter for wear, the diameter should not exceed 0.120" over the original diameter. When reboring brake drums, the finished diameter should not exceed 0.080" over the original diameter.

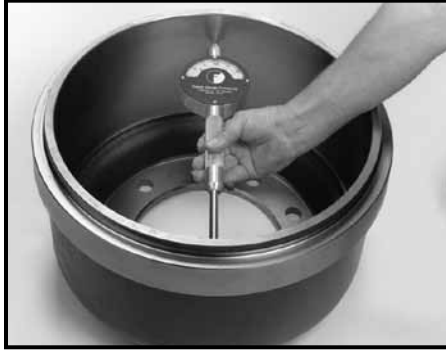
Oversized (Worn) Drums

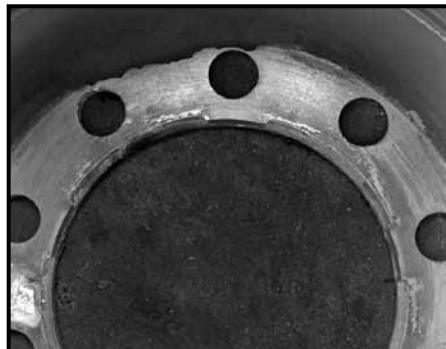
Broken mounting ring

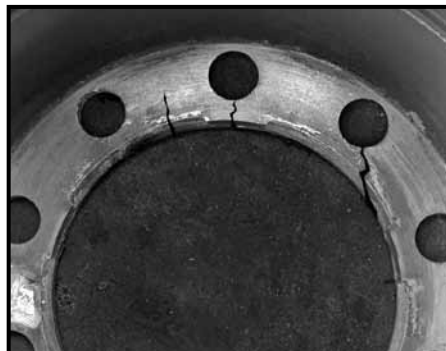
Radial cracking of the bolt holes on the mount surface

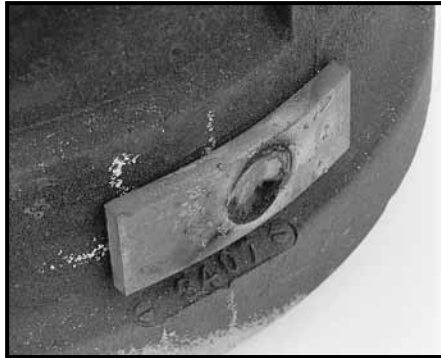
Welded balance weight

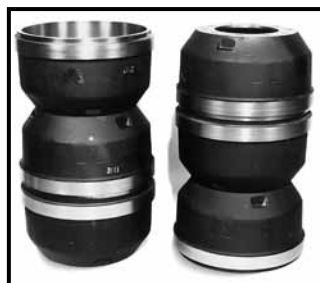
Drums should be stored in an area free from excess moisture and stacked as shown in Figure 1, to ensure proper distribution of weight on the sidewalls of the drum. Properly stacking new drums will avoid distortion of the sidewalls or damage to the braking surface.

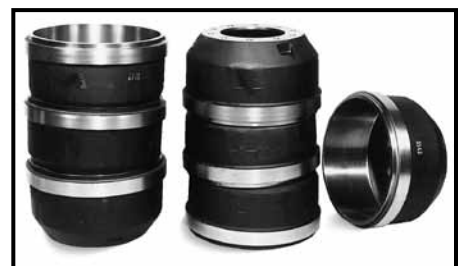
Storing brake drums by "nesting" one drum in another without a designed stacking feature or resting the drums on their side "book end", as shown in Figure 2, will result in damage to the drums. Storing drums in any of these ways will cause an out-of-round condition to occur which will require machining to restore concentricity before installation. This will significantly reduce the service life of the drum and create unnecessary expense due to the machining of a new drum.

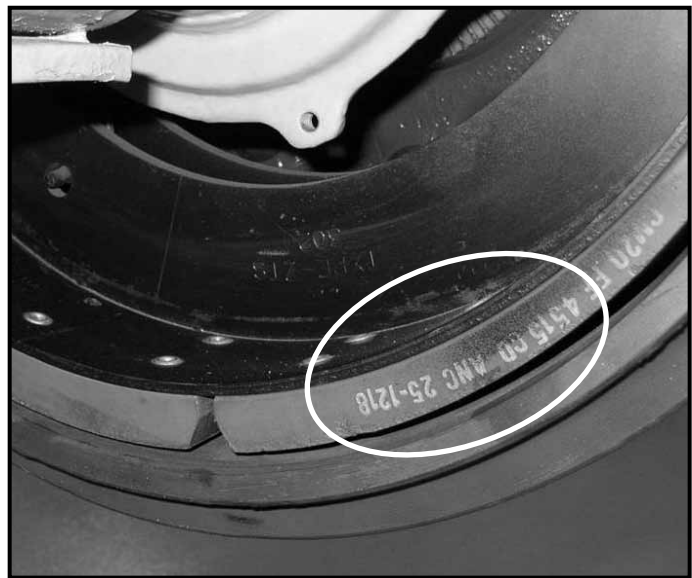
Mounting Gunite Brake Drums on "Hub Piloted" Wheel-end Assembly

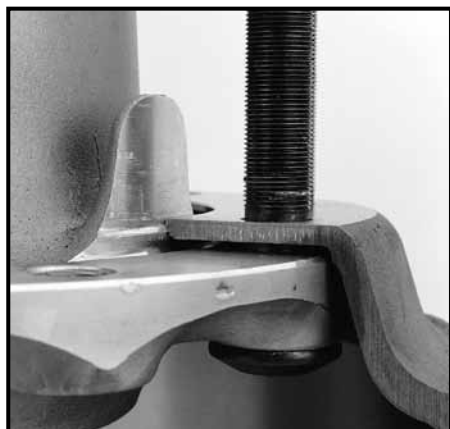
Figure 6 – Improper installation, drum is cocked and not properly seated on the drum pilot of the hub.

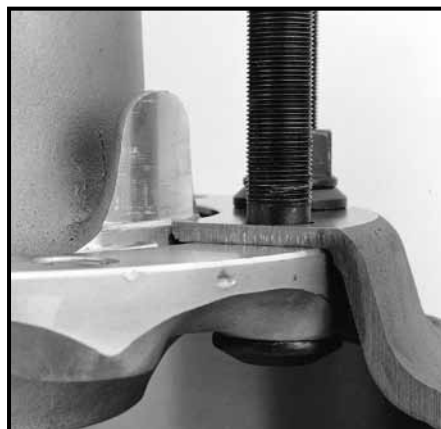
Figure 7 – Proper installation, drum is correctly positioned on the drum pilot and flat against the hub flange.

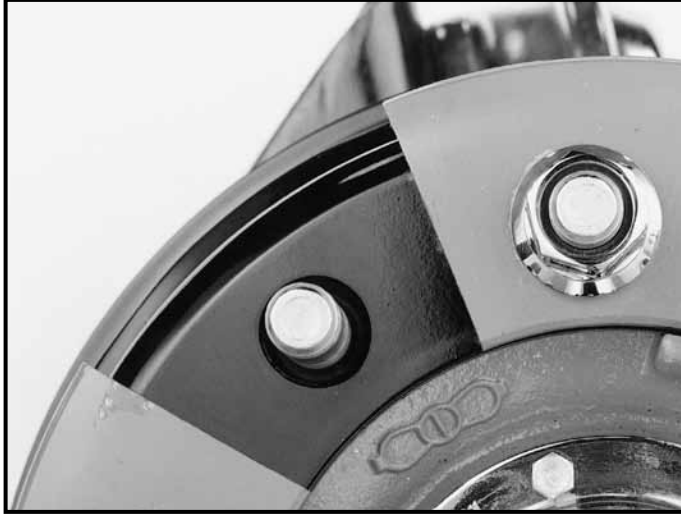
1-1/4" Bolt Hole Front Steer Axle Application
