Gunite Brake Drums

Maintenance and Installation Manual

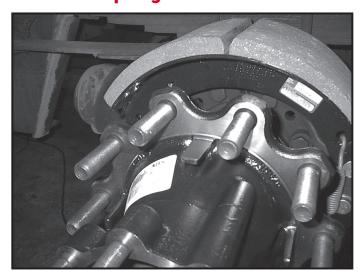
- Before installing drum, make sure that the brakes are in the fully released position to provide enough clearance over the brake shoes. Position the hub pilots to be in the 12 o'clock location as shown. Note: It is very important to make sure that the pilots are clean and free from rust or any other foreign material.
- Install drum over the wheel bolts and onto hubs drum pilot, insuring that it is flush against the hub flange. Care must be taken to avoid damaging the wheel bolt threads when mounting drum.
