Best Practice for Wheel Torque and Clamping Force

**Preventing Loose and Cracked
Wheels and Wheel End Components**

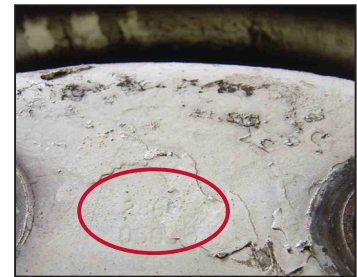
Visible signs that paint exceeds the maximum allowable thickness of 3.5 mils. Multiple coats, uneven surfaces, and illegible stampings indicate too much paint.

The maximum allowable paint thickness is .0035 inches (3.5 mils), which is about the thickness of a magazine page. If you cannot read the stamping, there is too much paint applied. **Such wheels should be repaired before being reinstalled on the vehicle.**

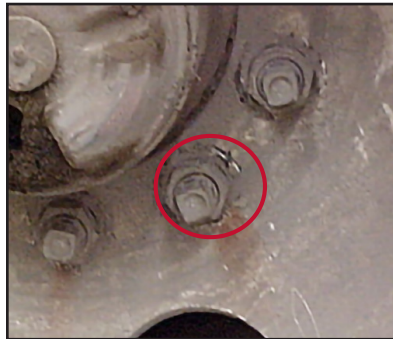
Bolt hole crack

- When checking wheels, look for signs of cracks and rust lines originating from bolt holes. These are common signs of low clamping force.
- If a stud is broken, you must replace the adjacent studs on either side of it. If two or more studs are broken, all studs must be replaced.

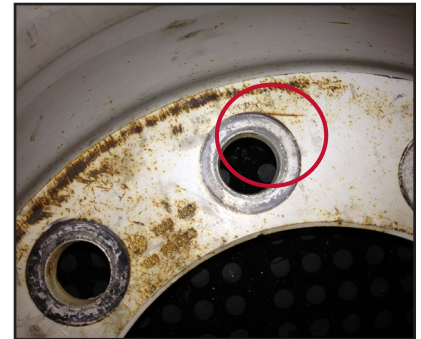
Edge of nut crack

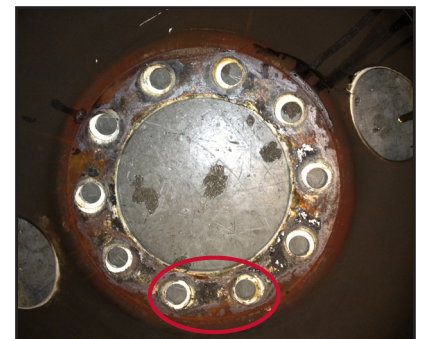
Scalloped witness mark

- Inspecting a wheel's back-up diameter during tire and brake changes may reveal a scalloped back-up diameter. This indicates low clamping force within the wheel end. Ensure that all mounting surfaces, studs, and nuts are properly cleaned and oiled as described in the Safety and Service manual before the wheel is reinstalled.
