## Best Practice for Wheel Torque and Clamping Force

**Preventing Loose and Cracked  
Wheels and Wheel End Components**

# Is Improper Maintenance Putting Your Fleet at Risk?

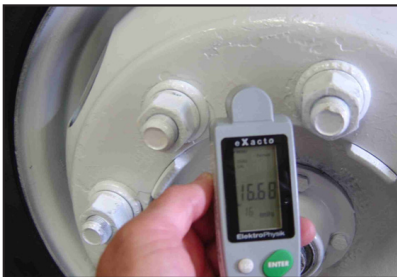
Paint thickness gauge reads 16.68 mils, above the maximum allowable thickness of 3.5 mils.

The maximum allowable paint thickness is .0035 inches (3.5 mils), which is about the thickness of a magazine page. If you cannot read the stamping, there is too much paint applied. **Such wheels should be repaired before being reinstalled on the vehicle.**

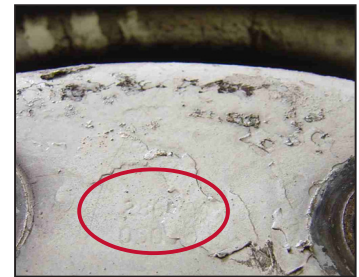
Visible signs that paint exceeds the maximum allowable thickness of 3.5 mils. Multiple coats, uneven surfaces, and illegible stampings indicate too much paint.

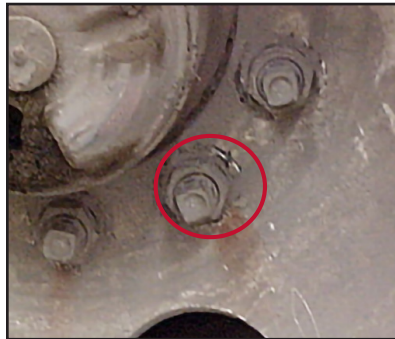
Bolt hole crack

- When checking wheels, look for signs of cracks and rust lines originating from bolt holes. These are common signs of low clamping force.
- If a stud is broken, you must replace the adjacent studs on either side of it. If two or more studs are broken, all studs must be replaced.

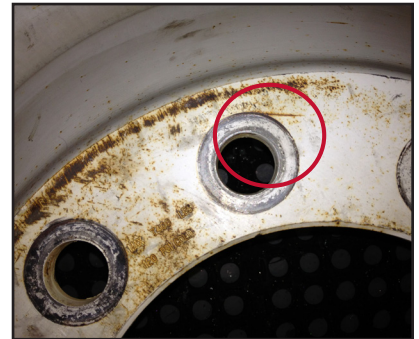
Edge of nut crack

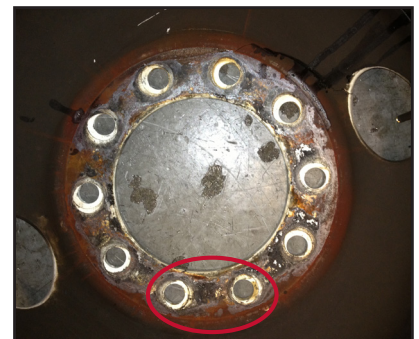
Scalloped witness mark

- Inspecting a wheel's back-up diameter during tire and brake changes may reveal a scalloped back-up diameter. This indicates low clamping force within the wheel end. Ensure that all mounting surfaces, studs, and nuts are properly cleaned and oiled as described in the Safety and Service manual before the wheel is reinstalled.
