Best Practice for Wheel Torque and Clamping Force

Preventing loose and cracked wheels and wheel end components

ACCURIDE™
WHEEL END SOLUTIONS

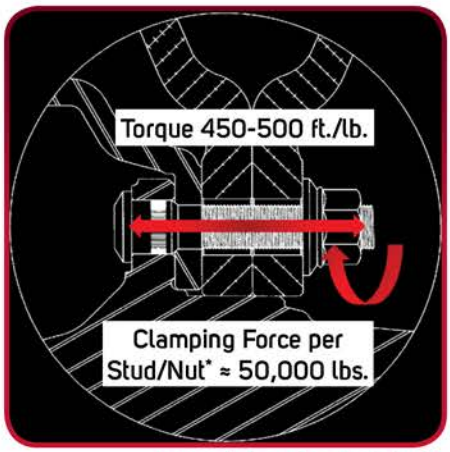
**New studs and used oiled nuts.*

- The ideal clamping force is achieved and maintained through the use of new fastening components that are applied using the manufacturer's specific torque and re-torque practice criteria (see chart on next page).

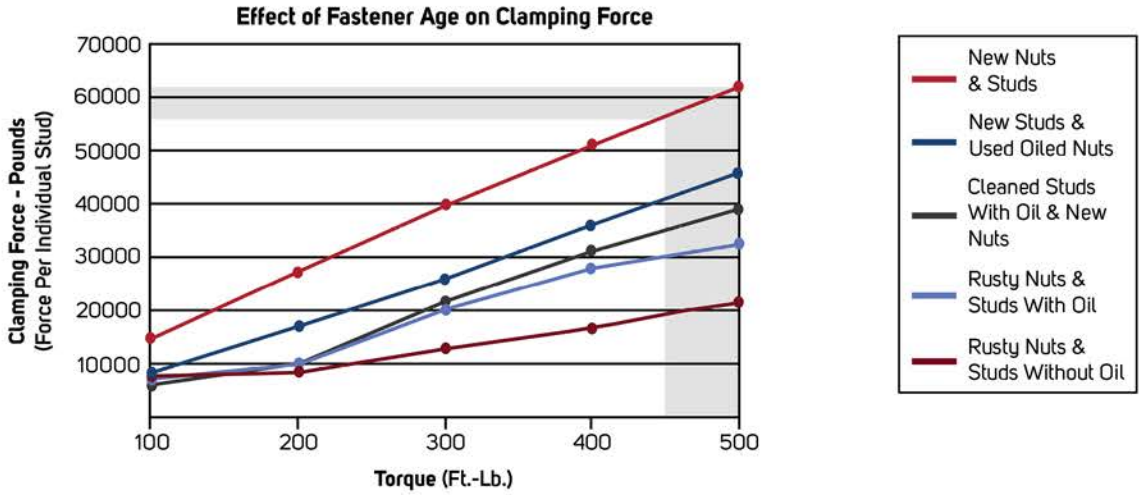
The condition of the studs and nuts has a direct impact on the level of torque that can be achieved.

(Study was done by using an M22 x 1.5 stud and two-piece flange nut)

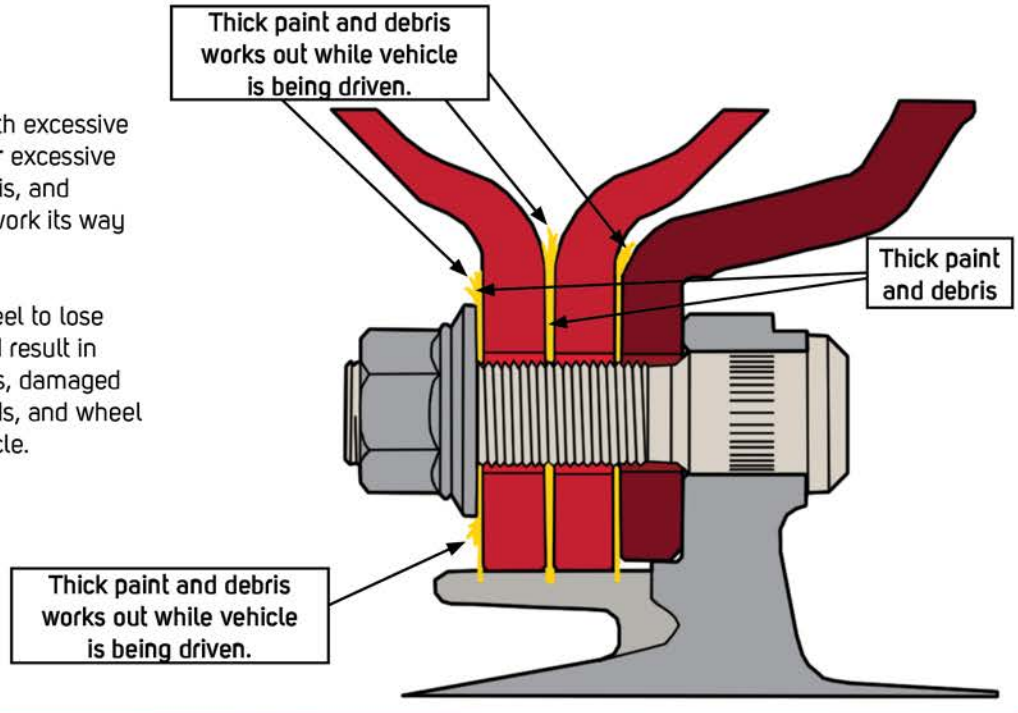
Paint thickness gauge reads 16.68 mils, above the maximum allowable thickness of 3.5 mils.

Visible signs that paint exceeds the maximum allowable thickness of 3.5 mils. Multiple coats, uneven surfaces, and illegible stampings indicate too much paint.

If wheels are installed with excessive paint thickness, debris, or excessive corrosion, the paint, debris, and corrosion will gradually work its way out during operation.

This could cause the wheel to lose clamping force and could result in cracked or broken wheels, damaged brake drums, broken studs, and wheel separation from the vehicle.

The maximum allowable paint thickness is 0.0035 inches (3.5 mils), which is about the thickness of a magazine page. If you cannot read the stamping, there is too much paint applied. **Such wheels should be repaired before being reinstalled on the vehicle.**
