Best Practice for Wheel Torque and Clamping Force

Preventing loose and cracked
wheels and wheel end components

Loose Torque vs. Over Torque

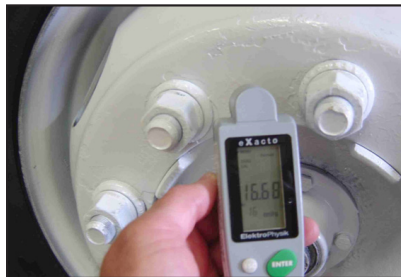
Paint thickness gauge reads 16.68 mils, above the maximum allowable thickness of 3.5 mils.

The maximum allowable paint thickness is .0035 inches (3.5 mils), which is about the thickness of a magazine page. If you cannot read the stamping, there is too much paint applied. **Such wheels should be repaired before being reinstalled on the vehicle.**

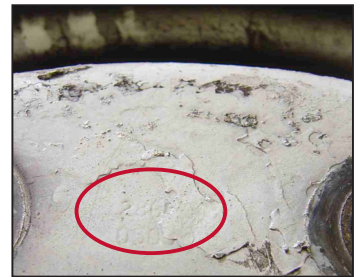
Visible signs that paint exceeds the maximum allowable thickness of 3.5 mils. Multiple coats, uneven surfaces, and illegible stampings indicate too much paint.
